New Hampshire Volunteer Lake Assessment Program

2003 Interim Report for Clough Pond Loudon

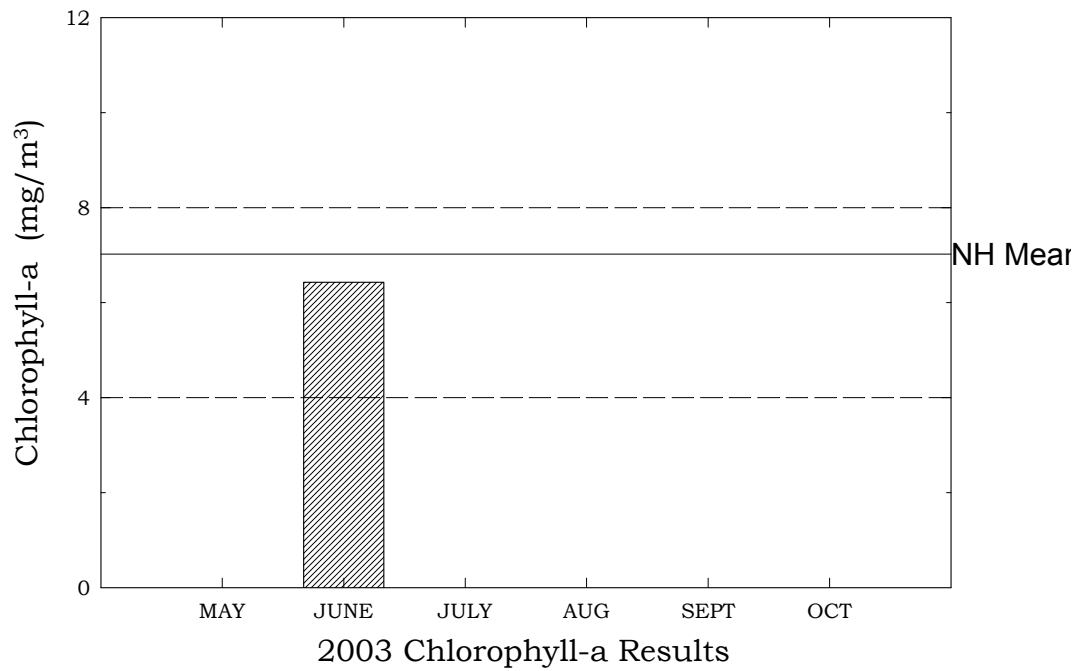
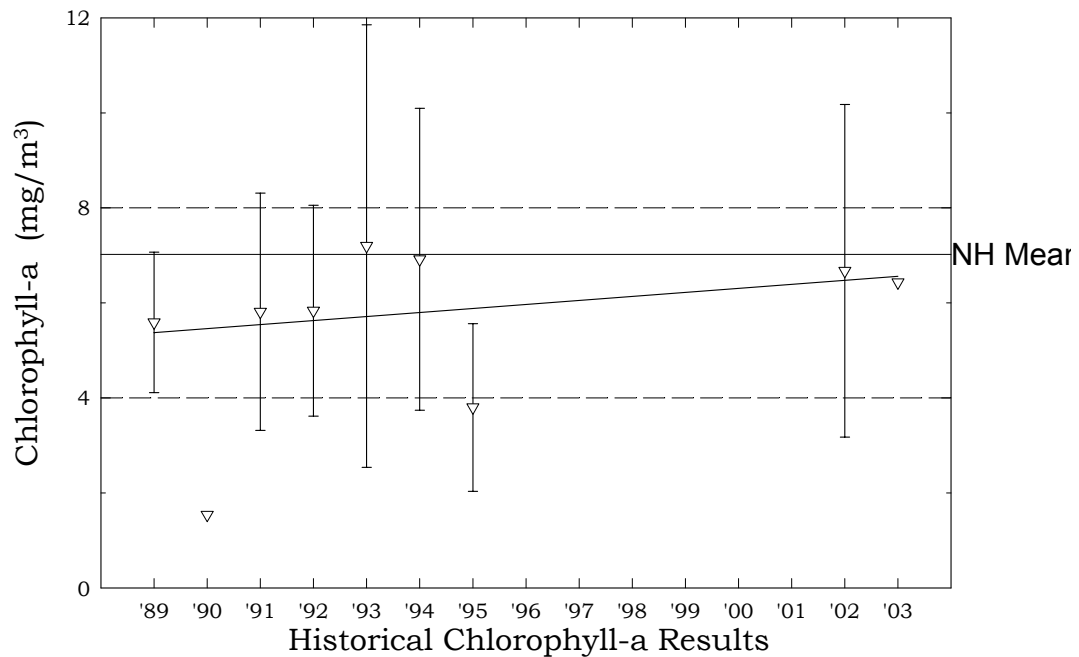
Figure 1. Monthly and Historical Chlorophyll-a Results

- **Figure 1 and Table 1:** The graphs in Figure 1 (Appendix A) show the historical and current year chlorophyll-a concentration in the water column. Table 1 (Appendix B) lists the maximum, minimum, and mean concentration for each sampling season that the lake/pond has been monitored through the program.

The current year data (the top graph) show that the chlorophyll-a concentration was 6.43 mg/m³ in June, which is *slightly less than* the state mean.

Overall, visual inspection of the historical data trend line (the bottom graph) shows *a variable, but overall relatively stable* in-lake chlorophyll-a trend, meaning that the concentration has *fluctuated, but has not continually increased or decreased* since monitoring began in 1989. (Please note that samples were not collected from 1996-2001) After 10 consecutive years of sample collection, we will be able to conduct a statistical analysis of the historic data to objectively determine if there has been a significant change in the annual mean chlorophyll-a concentration since monitoring began.

While algae are naturally present in all lakes/ponds, an excessive or increasing amount of any type is not welcomed. In freshwater lakes/ponds, phosphorus is the nutrient that algae depend upon for growth. Algal concentrations may increase with an increase in nonpoint sources of phosphorus loading from the watershed, or in-lake sources of phosphorus loading (such as phosphorus releases from the sediments). Therefore, it is extremely important for volunteer monitors to continually educate residents about how activities within the watershed can affect phosphorus loading and lake/pond quality.

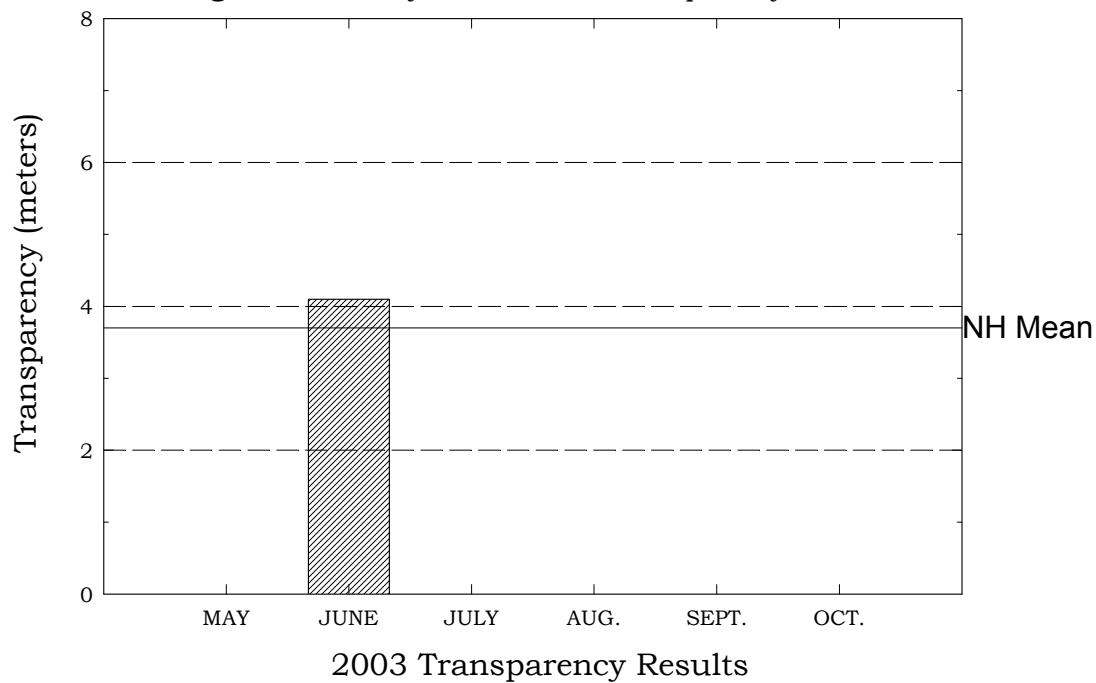
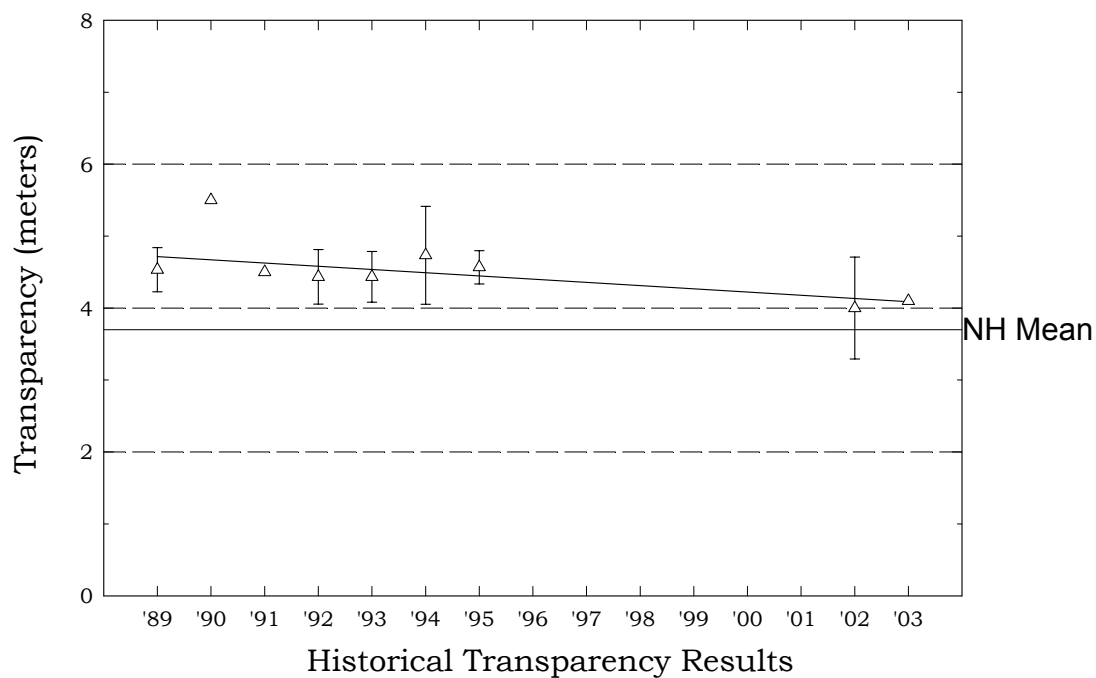
Figure 2. Monthly and Historical Transparency Results

- **Figure 2 and Table 3:** The graphs in Figure 2 (Appendix A) show historical and current year data for lake/pond transparency. Table 3 (Appendix B) lists the maximum, minimum and mean transparency data for each sampling season that the lake/pond has been monitored through the program.

The current year data (the top graph) show that the in-lake transparency was 4.1 meters in June, which is *slightly greater than* the state mean.

Overall, visual inspection of the historical data trend line (the bottom graph) shows **a relatively stable** trend for in-lake transparency, meaning that the transparency has **remained approximately the same** since monitoring began in 1991. Again, note that samples were not collected from 1996 to 2001. After 10 consecutive years of sample collection, we will be able to conduct a statistical analysis of the historic data to objectively determine if there has been a significant change in the annual mean transparency since monitoring began.

Typically, high intensity rainfall causes erosion of sediments into lakes/ponds and streams, thus decreasing clarity. Efforts should continually be made to stabilize stream banks, lake/pond shorelines, disturbed soils within the watershed, and especially dirt roads located immediately adjacent to the edge of tributaries and the lake/pond. Guides to Best Management Practices designed to reduce, and possibly even eliminate, nonpoint source pollutants, such as sediment loading, are available from DES upon request.

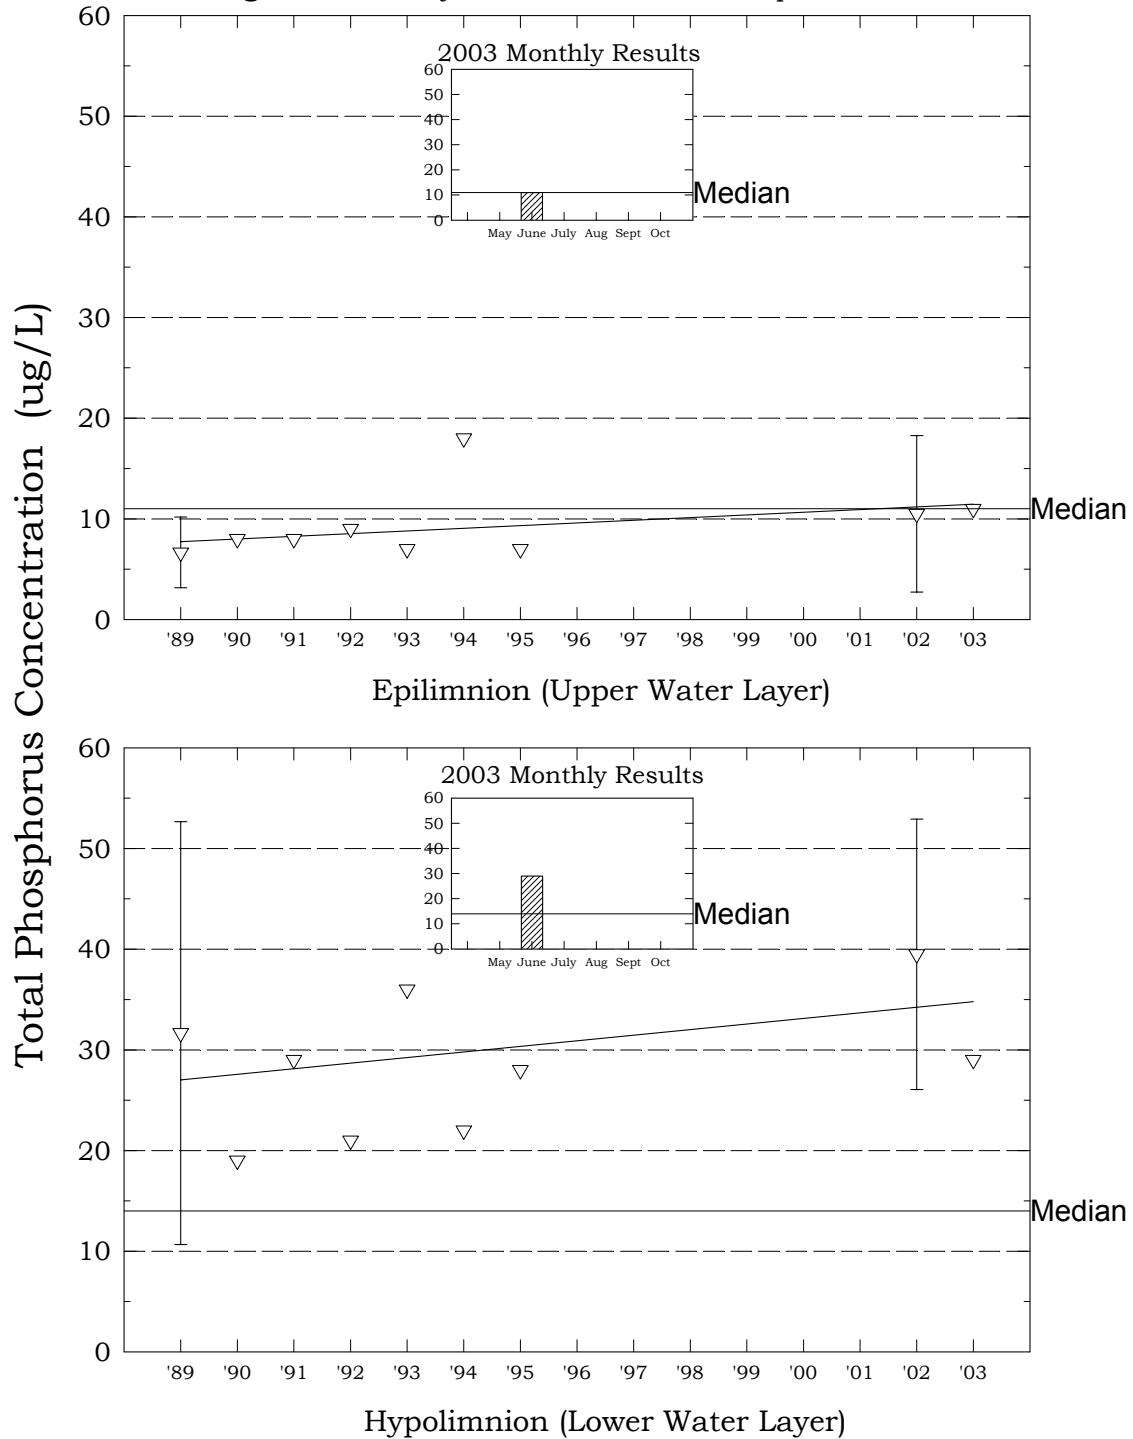
Figure 3. Monthly and Historical Total Phosphorus Data.

- **Figure 3 and Table 8:** The graphs in Figure 3 (Appendix A) show the amounts of phosphorus in the epilimnion (the upper layer) and the hypolimnion (the lower layer); the inset graphs show current year data. Table 8 (Appendix B) lists the annual maximum, minimum, and median concentration for each deep spot layer and each tributary since the lake/pond has joined the program.

The current year data for the epilimnion (the top inset graph) show that the phosphorus concentration was 20 ug/L in June, which is **greater than** the state median.

The current year data for the hypolimnion (the bottom inset graph) show that the phosphorus concentration was 29 ug/L in June, which is **greater than** the state median.

Overall, visual inspection of the historical data trend line for the epilimnion shows **a slightly increasing** phosphorus trend, which means that the concentration has **worsened slightly** in the epilimnion since monitoring began.

Overall, visual inspection of the historical data trend line for the hypolimnion shows **variable, but overall slightly increasing** phosphorus trend, which means that the concentration has **fluctuated, but overall slightly worsened** in the hypolimnion since monitoring began. (Again, please note that no samples were collected between 1996 and 2001.)

One of the most important approaches to reducing phosphorus loading to a waterbody is to continually educate watershed residents about its sources and how excessive amounts can adversely impact the ecology and value of lakes and ponds. Phosphorus sources within a lake or pond's watershed typically include septic systems, animal waste, lawn fertilizer, road and construction erosion, and natural wetlands.
